# Landslides in Alaska

Alaska Division of Geological & Geophysical Surveys

# Recent Alaska Landslides

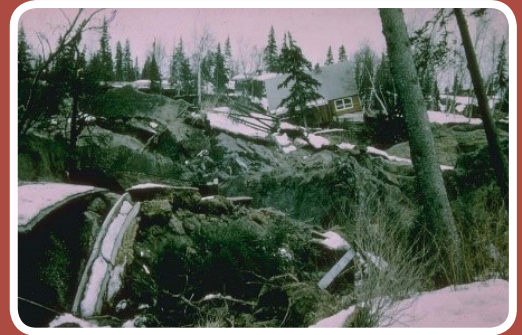
Landslide damage, 1964 Great Alaska Earthquake

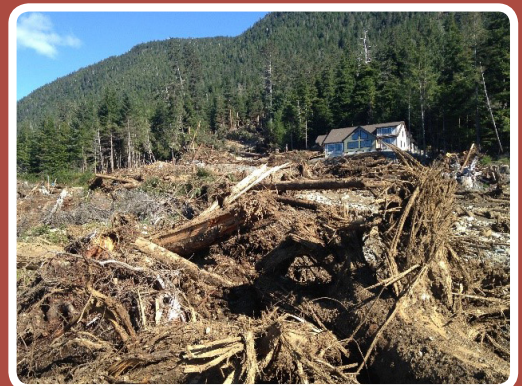
**Sitka Debris Flows.** On August 18, 2015, heavy rains resulted in numerous landslides in and around Sitka, Alaska. More than 45 landslides were initiated during this rainfall event. Four debris flows (very water-rich landslides) impacted homes and infrastructure in Sitka, and this one took the lives of three Sitka residents.

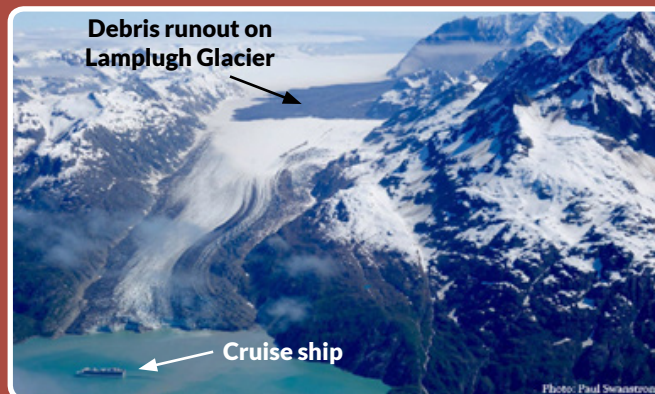
**Lamplugh Glacier Snow-Ice-Rock Avalanche.** On June 28, 2016, a massive landslide crashed onto a glacier in Glacier Bay, Southeast Alaska. More than 100 million tons of rock, snow, and ice slid down a mountainside, sending debris six miles down Lamplugh Glacier. Snow-ice-rock avalanches like this are becoming more common with receding glaciers.

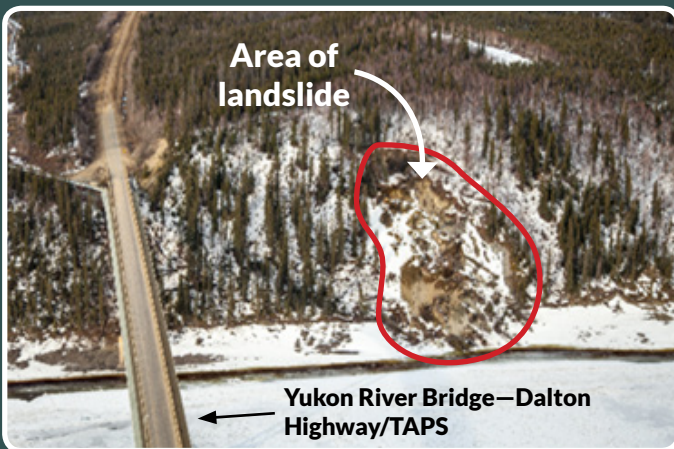
**Yukon River Bridge Landslide.** In 2012 a landslide occurred approximately 375 feet from the Dalton Highway bridge over the Yukon River. The Dalton Highway and the Trans-Alaska Pipeline System rely on the bridge to connect Fairbanks to the Prudhoe Bay oilfields, ensuring an uninterrupted corridor for the transportation of supplies and personnel. Any compromise to the bridge's integrity could potentially have immediate and severe consequences to the state's economy and environment. Although there was no damage to the bridge foundation, the landslide's close proximity to the bridge raised concerns over additional potential failures.

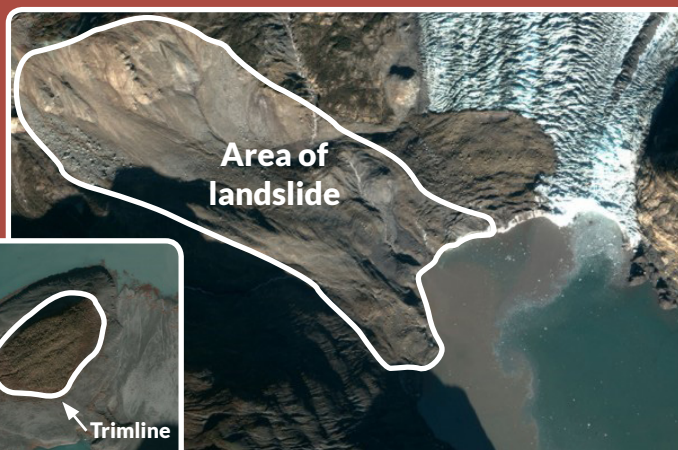
**Icy Bay Landslide.** After a period of heavy rains, a mountainside near Tyndall Glacier collapsed on October 17, 2015, dropping 200 million tons of rock into a fjord of Icy Bay. The displaced water generated a wave that denuded vegetation more than 500 feet up on a hillside across from the slide.
